PRELIMINARY VIBRATION AND FLUTTER STUDIES ON P-47 TAIL

By Theodore Theodorsen

Langley Memorial Aeronautical Laboratory
Langley Field, Va.

MEMORANDUM REPORT

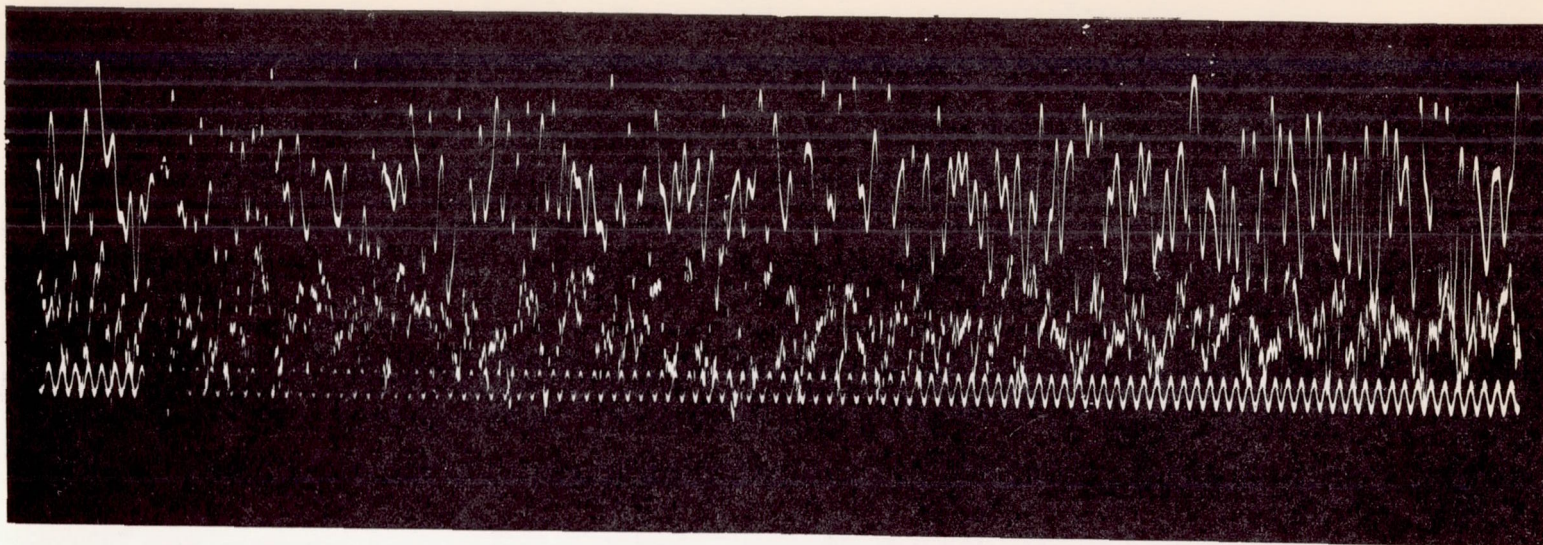
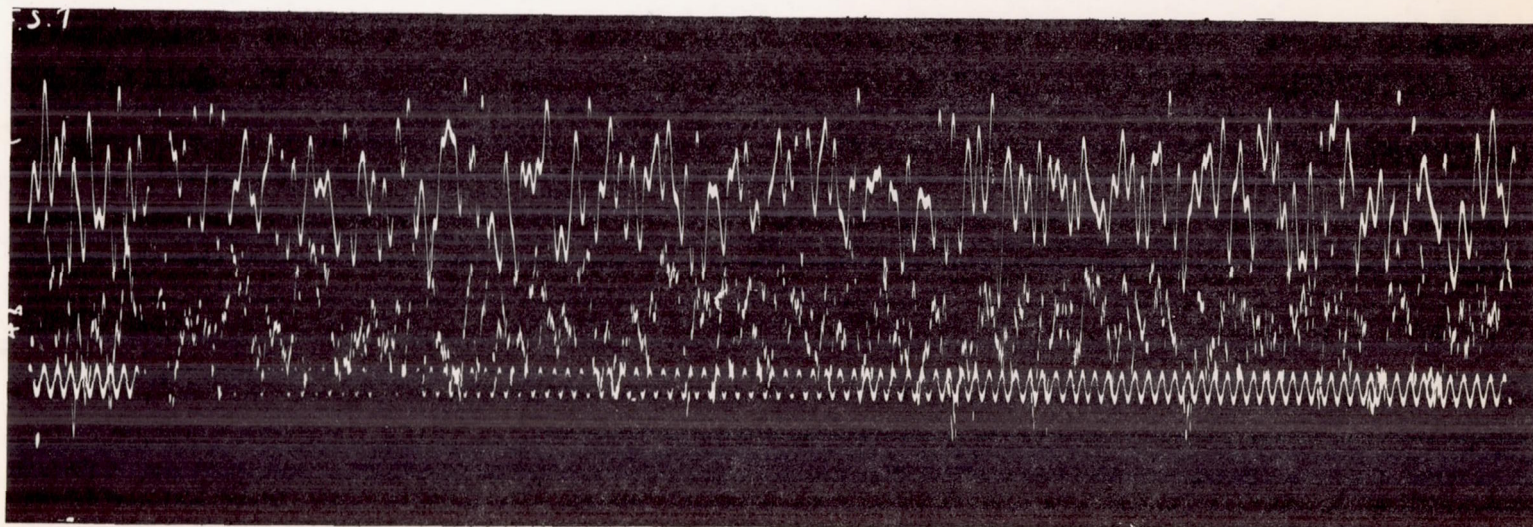
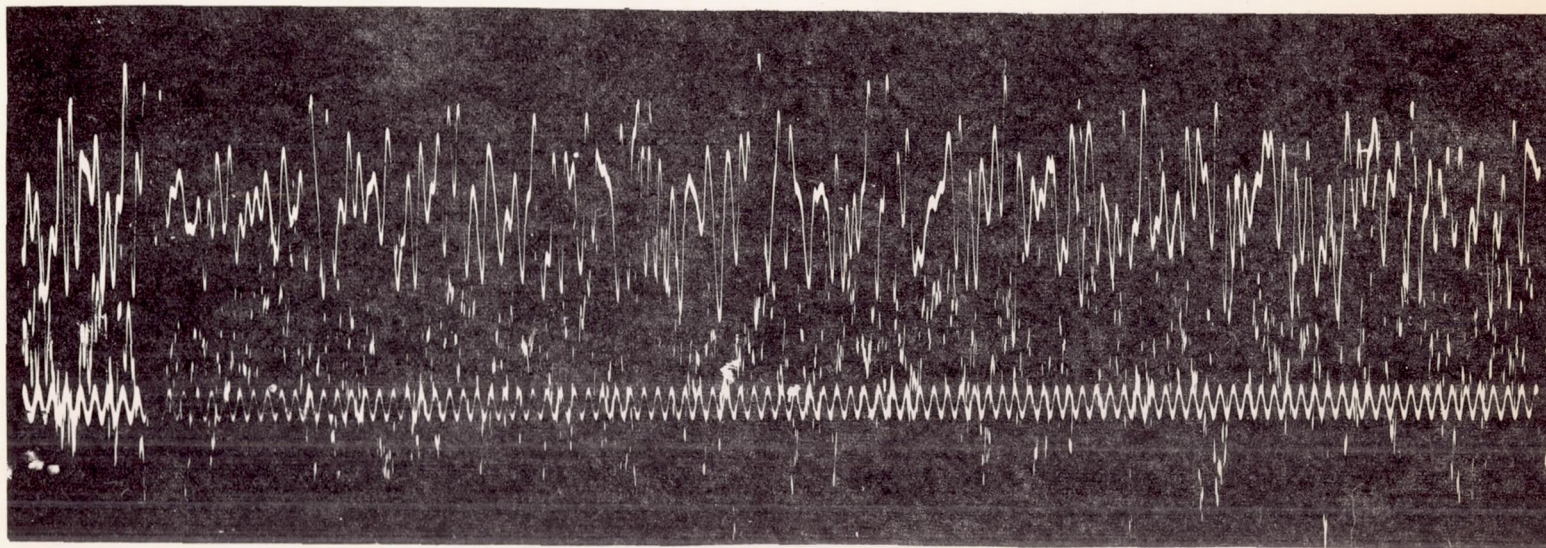
Figure 1.- Concluded.

amplified and recorded on an oscillograph. A sample record taken at 85 miles per hour is given in figure 1. The upper trace is obtained on the wire strain gage or "fish tail" and the lower record is taken with a hot-wire pickup, both in the air stream immediately behind the rudder. The timing wave at the bottom is a 300-cycles-per-second sine wave.

Airspeed, 85 mph; L, 0.7° ; rudder deflection, 0°

Airspeed, 85 mph; L , 0.7° ; rudder deflection, 0° .

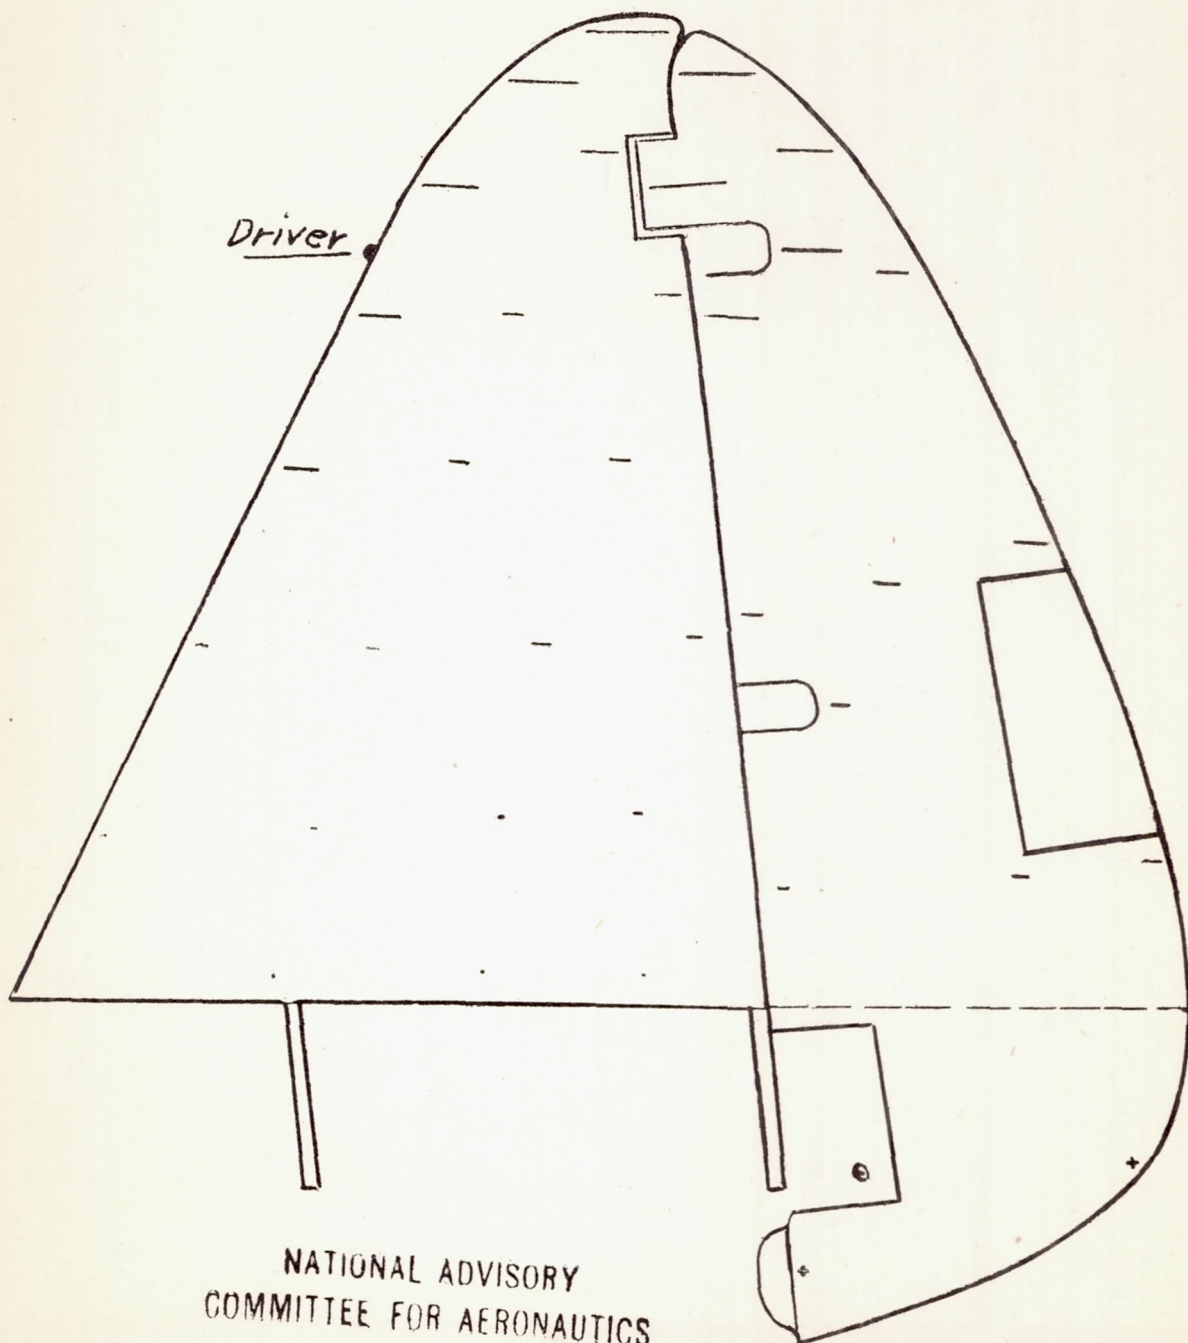
FIGURE 2

In these figures, the plus and minus signs designate the phase, with the size of the signs approximately indicating the magnitude of the motion at each point. For instance, in figure 2, it can be noted that the entire surface is in the same phase, with the largest deflection near the top as

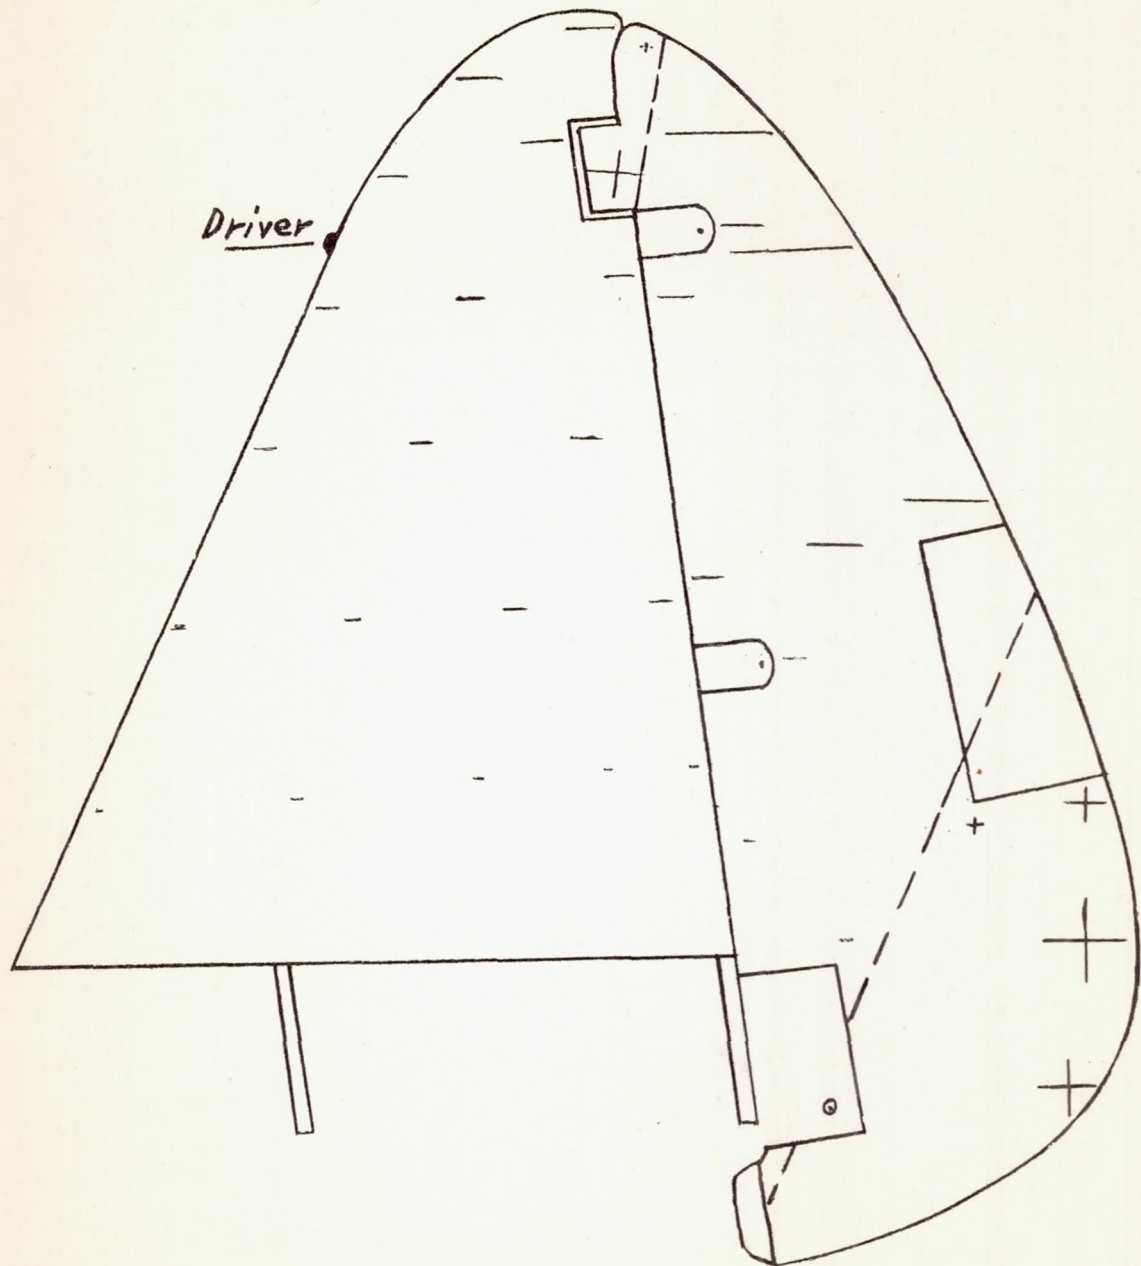
FIGURE 3.

expected. In the second figure (fig. 3), it is seen that the entire unit again is in phase except for the upper balance weight and the lower rear corner of the rudder.

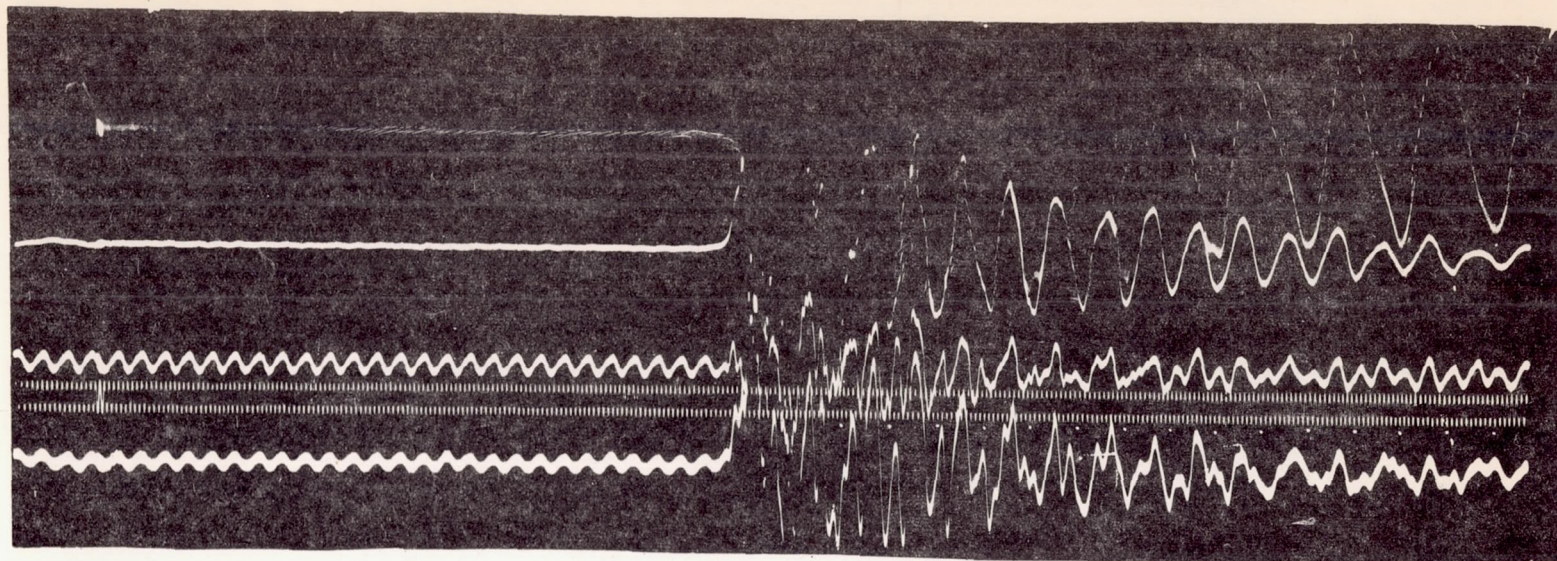
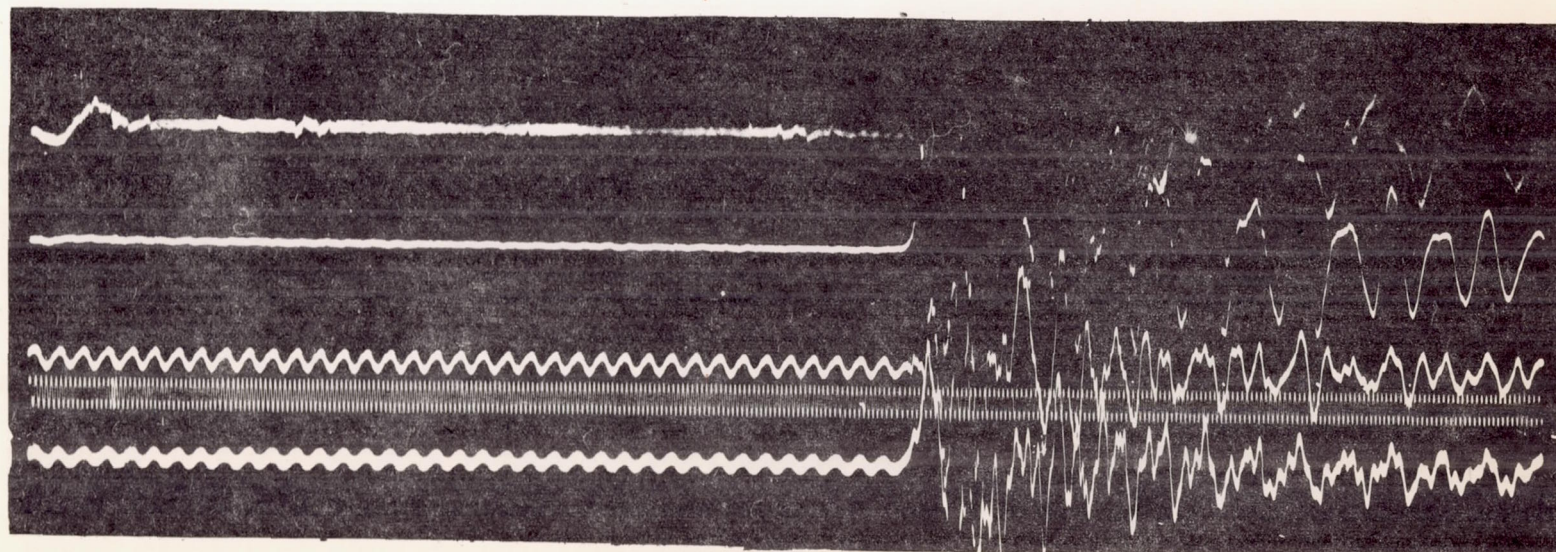
Figure 13.- Concluded.

The first interesting observation can be made in regard to the apparent rudder damping. The trace, G, shows this most plainly. At zero airspeed (figs. 13(c) and (d)) the records show a small damping as expected. In figure 14, taken at approximately 200 miles per hour, it is noted that the large deflection in G, obtained in each case by releasing the trip mechanism, appears nearly critically damped. In R and B about three successive excursions are visible;

Rudder jerked; airspeed, 0.

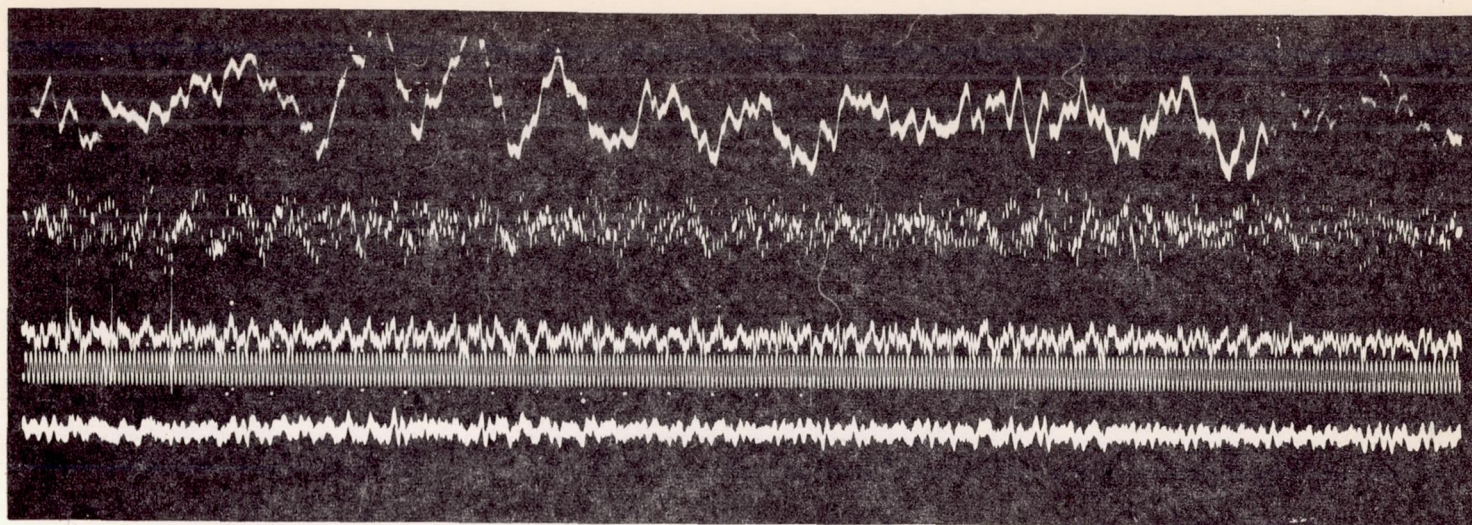
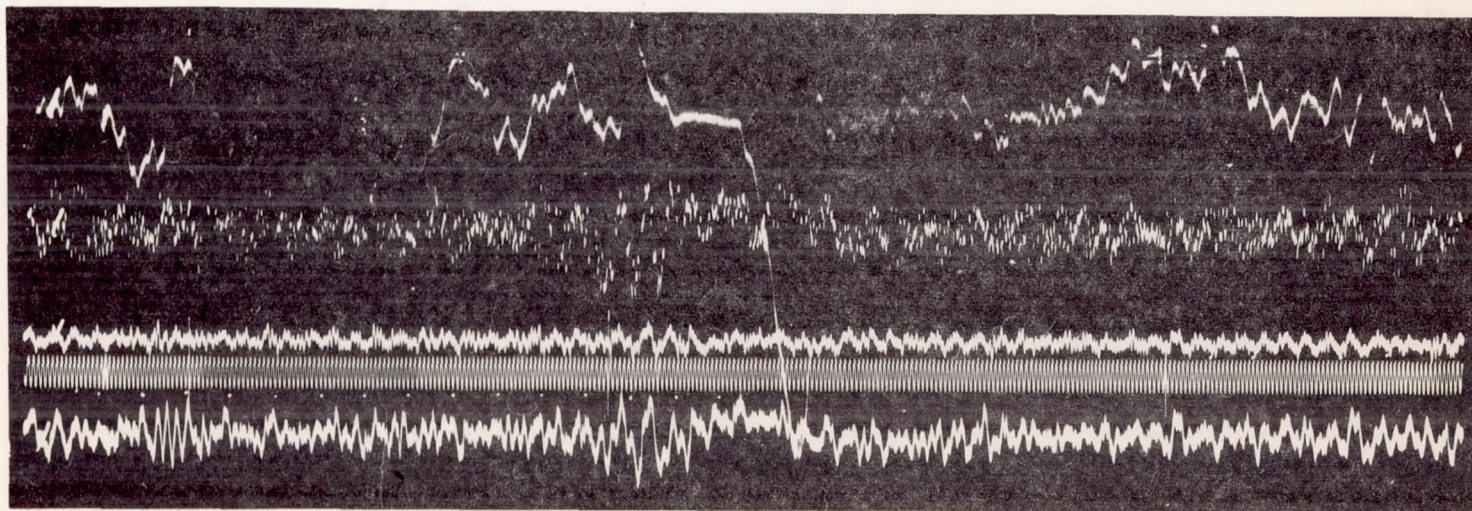
Airspeed, 200 mph.

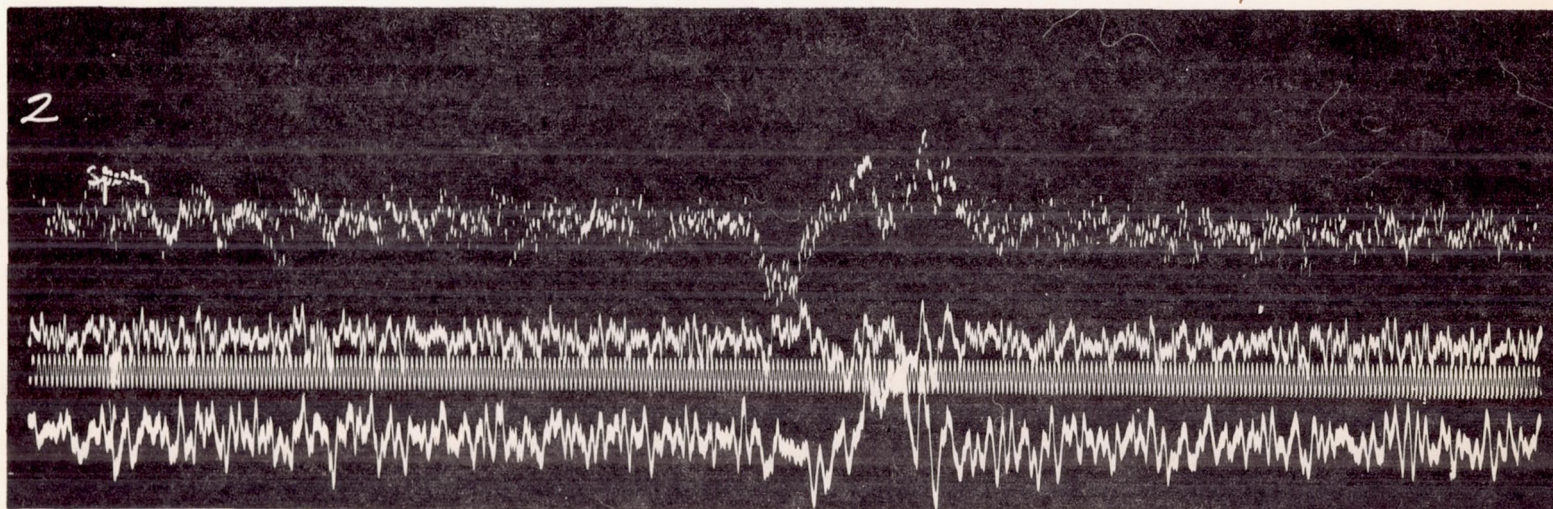
Figure 16.

Y shows little response. Records in figures 16 and 17 taken at 300 miles show a similar damping. At 350 miles per hour (fig. 19), the response, B, is still well damped, but the torsion element, B, and the rib element, B, show several successive waves after each tripping of the rudder (figs. 22 to 26).

Airspeed, 300 mph.

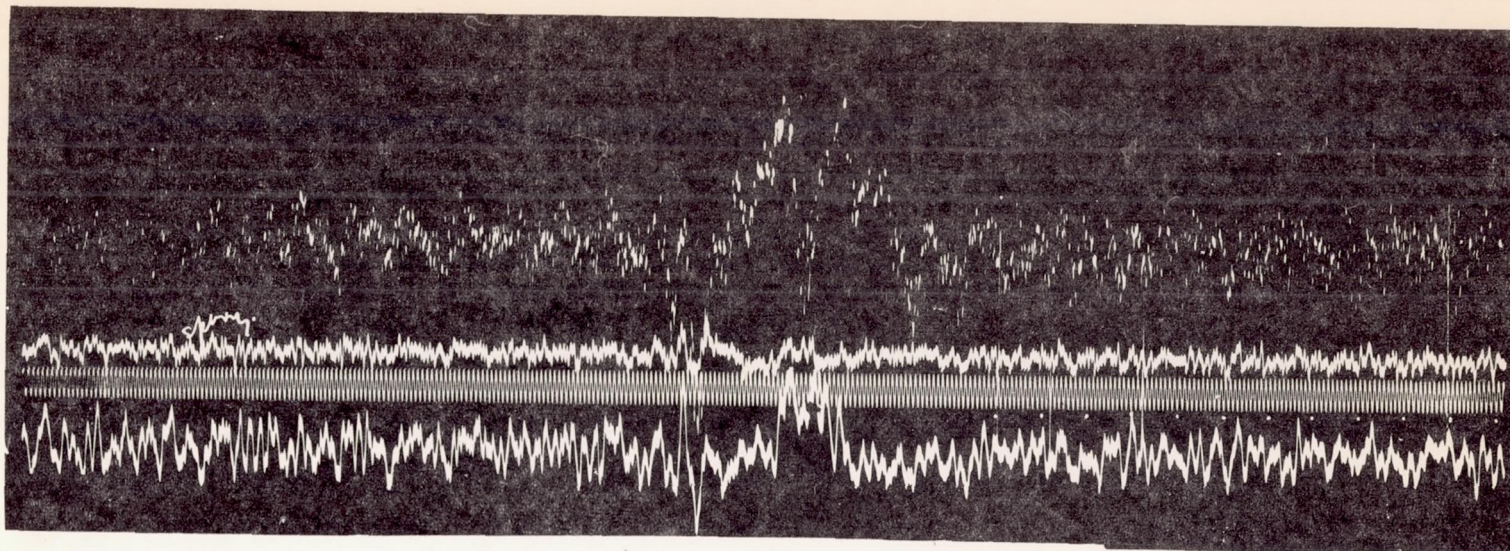
Figure 17.

Airspeed, 300 mph.

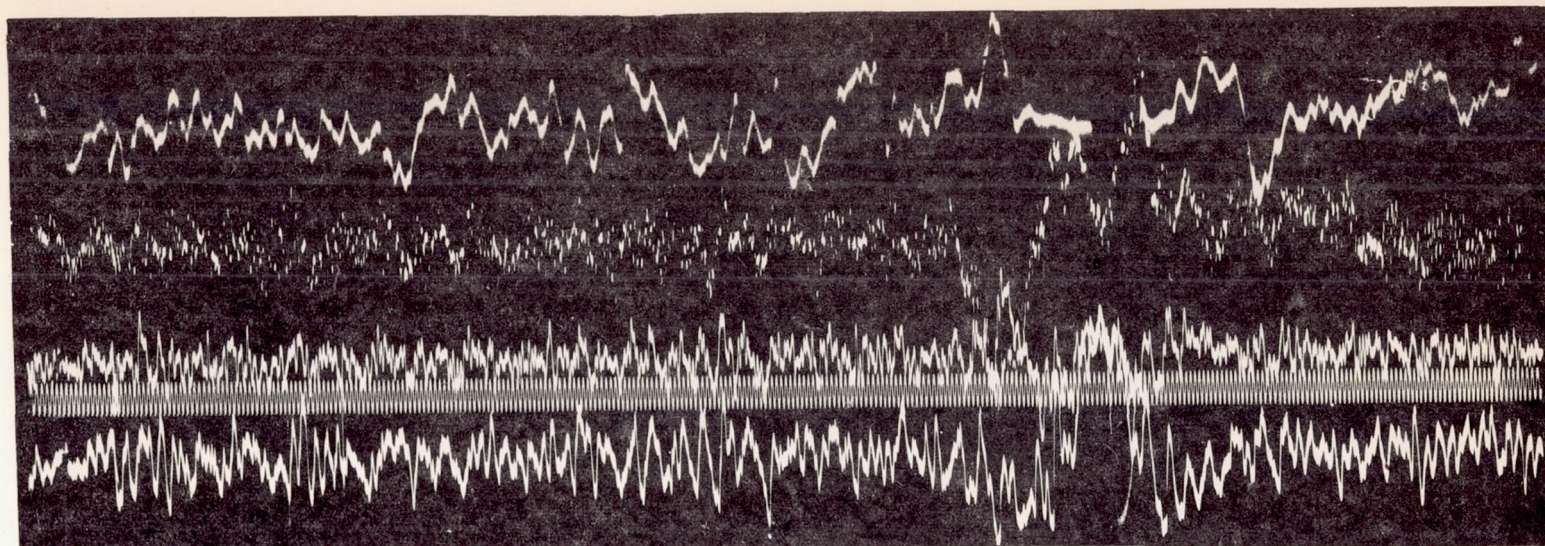
Figure 19.

Airspeed, 350 mph.

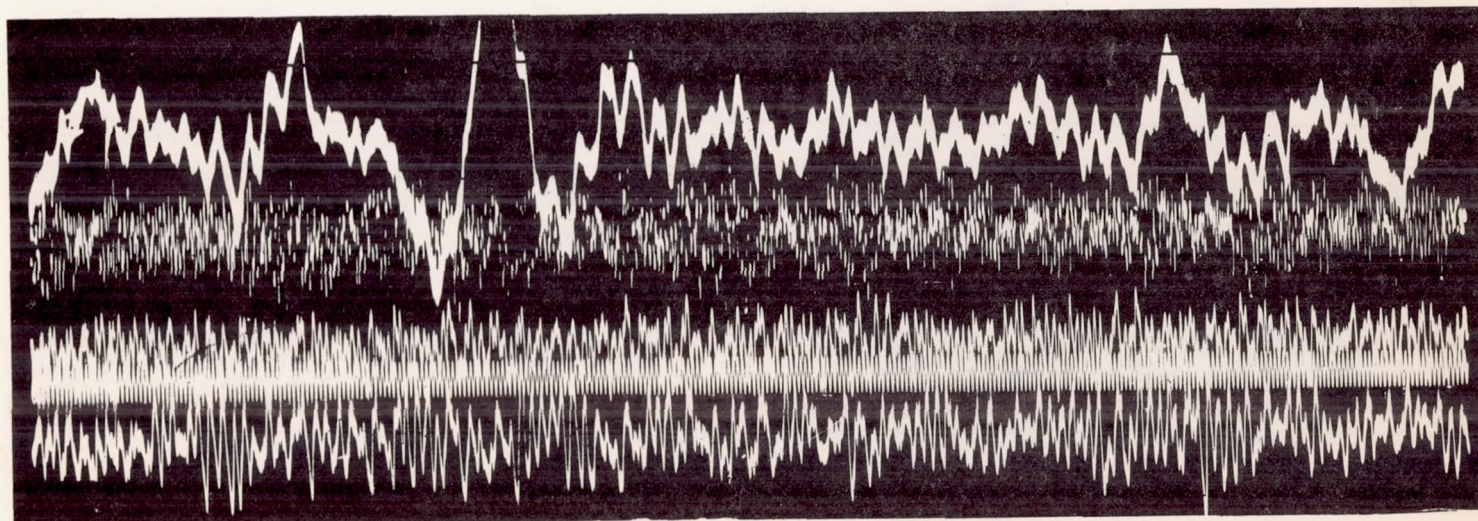
Figure 22.

At approximately 400 miles per hour, there are four to five large peaks appearing in the fin-bending record, G, and evidently similar disturbances in the other three. In other words, the damping is starting to disappear, which fact is significant of the approach to a condition of flutter involving these particular responses. However, flutter in these combinations of lower frequency modes evidently did not develop. It is noted that at about 420 miles per hour (fig. 27) a very high frequency of about 140 cycles per second comes into evidence. At 440 miles per hour (fig. 28) the damping in the low bending appears fairly unchanged but the high frequency of about 140 cycles per second starts to dominate the record.

Airspeed, 400 mph.

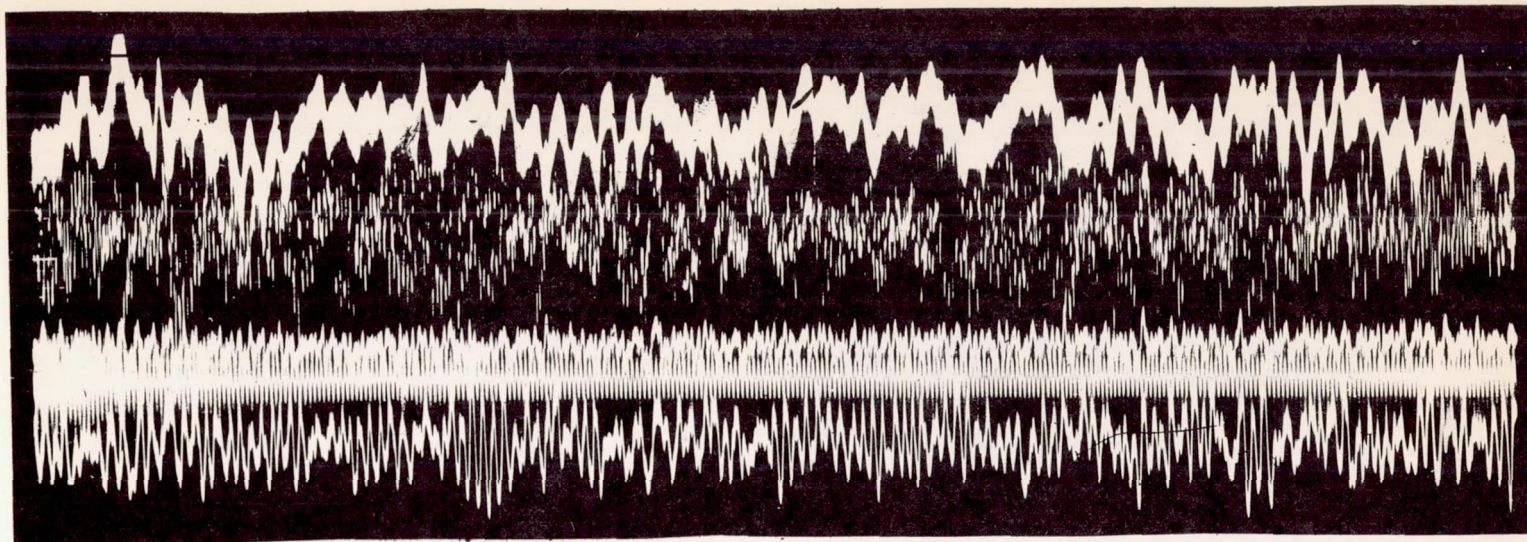
Figure 23.

Airspeed, 400 mph.

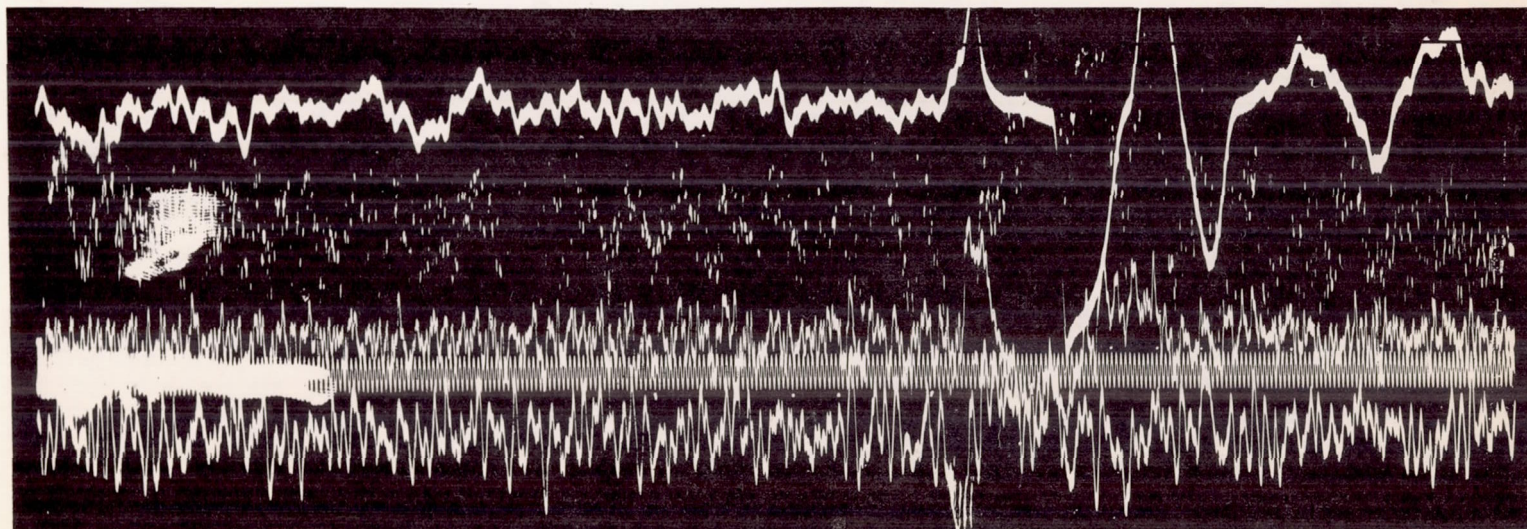
Figure 24.

Airspeed, 400 mph.

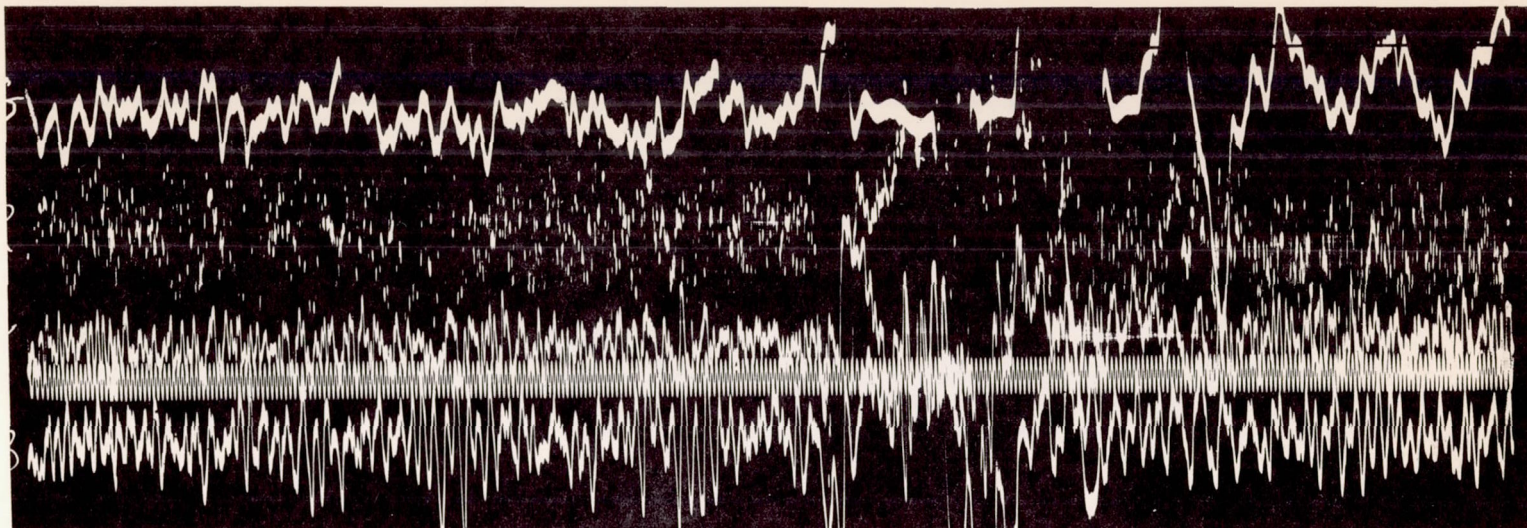
Figure 25.

Airspeed, 400 mph.

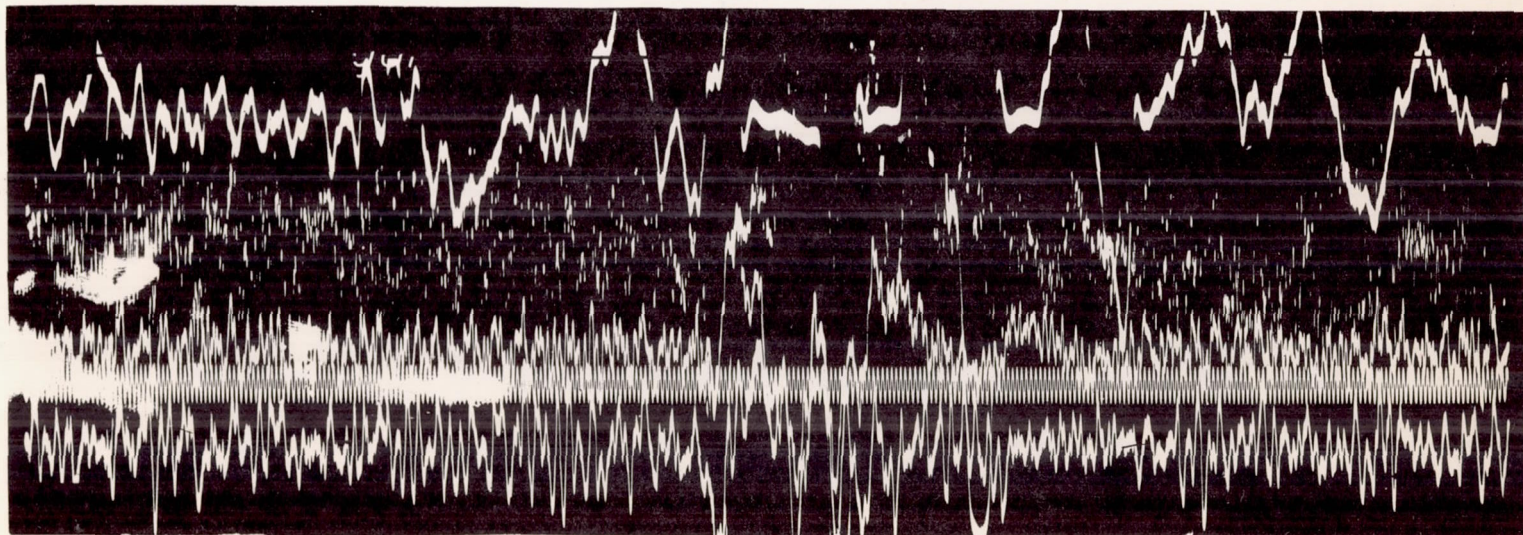
Figure 26.

Airspeed, 400 mph.
